Rail Transportation Safety Investigation Report R19H0123

MAIN-TRACK TRAIN COLLISION WITH STANDING CUT OF CARS FOUL OF THE MAIN TRACK

VIA Rail Canada Inc.
Passenger train 48
Mile 186.68, Canadian National Railway Company Kingston Subdivision
Ernestown, Ontario
05 September 2019

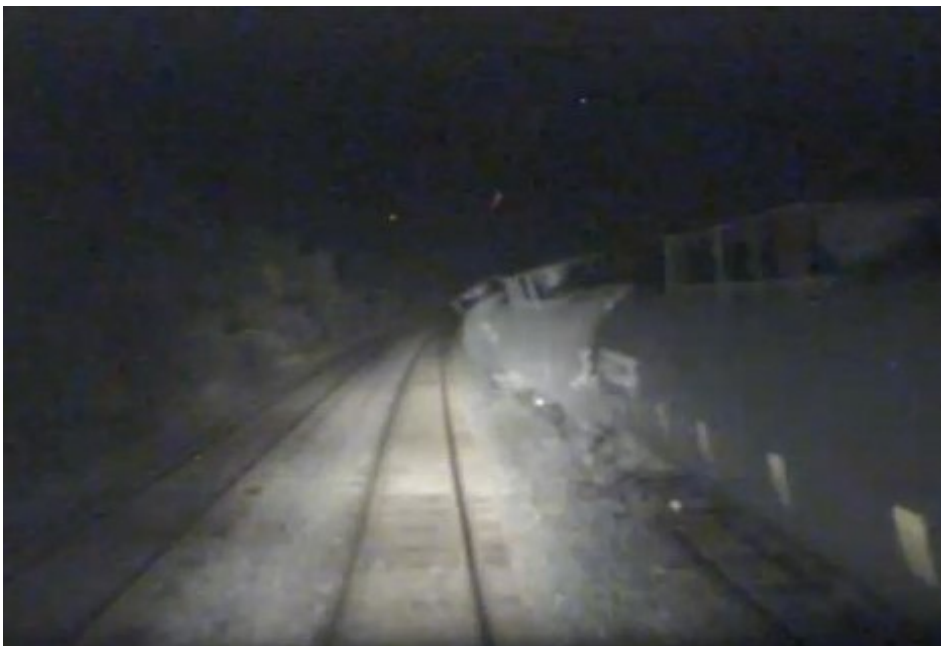
At 2115, while VIA 48 was proceeding at 62 mph on the south main track and rounding a right-hand curve, the operating crew observed 2 tank cars² on track KN-03, which was adjacent to and south of the main track, leaning to the north and foul of the main track at Mile 186.68 (Figure 2).

Figure 2. Tank cars on track KN-03 foul of the south main track at Mile 186.68 (Source: VIA Rail Canada Inc.)

Just moments before the arrival of VIA 48, the crew of CN road switching assignment L51931-05 (CN 519) was shoving cars into track KN-04. The assignment struck the cars on track KN-03, pushing them foul of the main track.

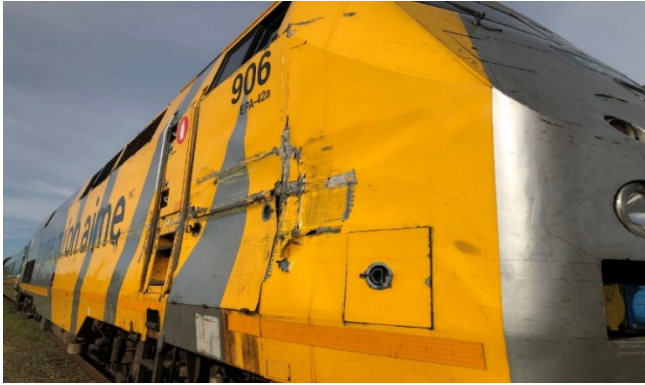
The two VIA trains did not collide or derail, and no injuries were reported. However, as a result of the side-swipe collision, the entire south side of the VIA 48 train received significant damage (figures 3 and 4). The tank car jackets and running gear of the 2 tank cars were also damaged.

Figure 3. Damaged lead locomotive of VIA 48 (Source: VIA Rail Canada Inc.)

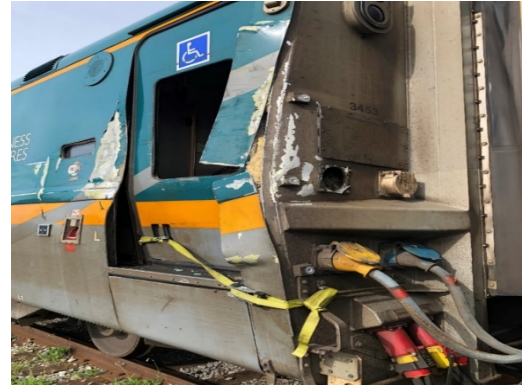
Figure 4. Damaged business LRC car of VIA 48 (Source: VIA Rail Canada Inc.)

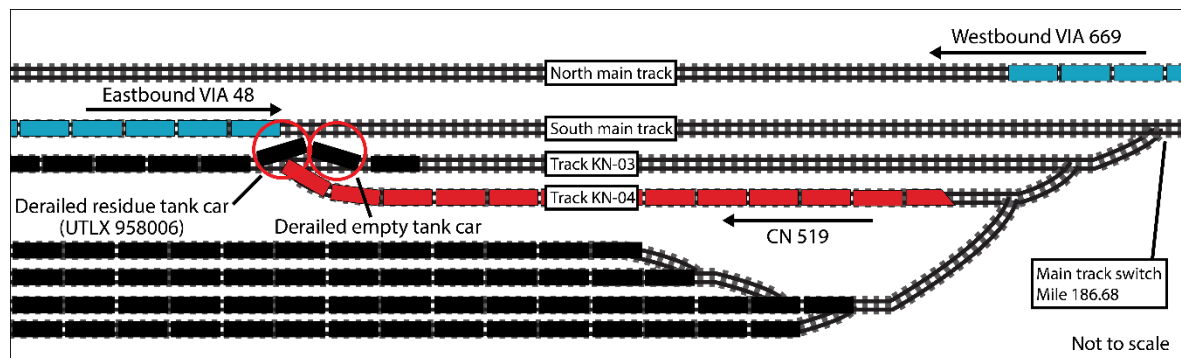
The CN 519 crew were unaware that their movement had been shoved through the west end of track KN-04 into the side of 2 tank cars standing on track KN-03, causing the cars to derail to the north, and foul of the Kingston Subdivision south main track (Figure 5).

Figure 5. Accident site diagram showing the track layout and the positions of VIA 48, VIA 669, CN 519 and the derailed tank cars (Source: TSB)

Track KN-04 was approximately 1300 feet long and CN 519 was approximately 1185 feet long. This left approximately 115 feet of buffer space, or just over 2 car lengths. Because the conductor did not want to leave the locomotives foul of the east switch for KN-04, he stopped the movement when the locomotives were clear of the switch by about 3 car lengths (150 feet). In this case, with only about a year of operating experience (mostly in through freight service), the conductor lacked sufficient experience to properly estimate the length of the track required to safely apply the exception to CROR Rule 115.
