Railroad Investigation Report: RIR-22/10

BNSF Railway Employee Fatality

Louisiana, Missouri
April 7, 2021

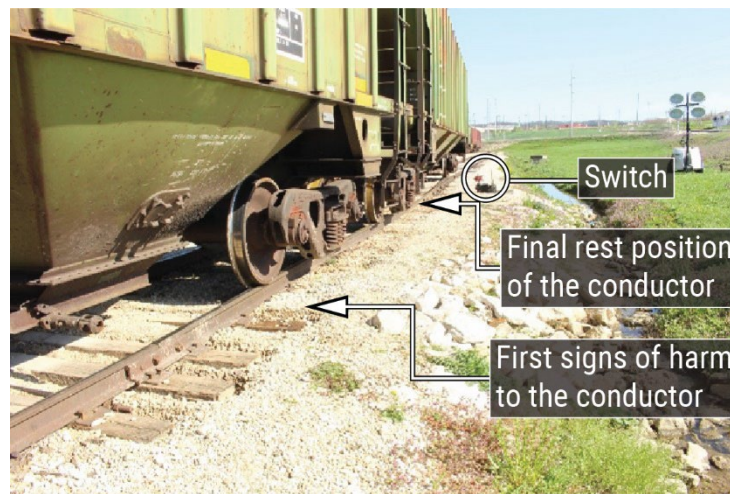
The brakeman announced “emergency” over the handheld radio, and the engineer dialed 911 on the locomotive radio. Shortly after the call to 911, emergency responders arrived on-scene and the conductor was pronounced deceased. While on-scene, the responders identified the first signs of harm to the conductor in the ballast on a walking space adjacent to the tracks near the accident location.⁶ (See figure 2.)

Figure 2. Area where the conductor was found.

While there were no witnesses, and surveillance video footage did not capture the accident, the responders identified the first signs of harm to the conductor in the ballast near the accident location with insufficient walking space. Further, NTSB investigators found the walking space where the conductor was likely protecting the train movement from the ground to be challenging terrain consisting of a narrow walkway with a steep, rocky drop-off into a drainage ditch.
